Letter Health Consultation

WAYNESVILLE PHARMACY

WAYNESVILLE, NORTH CAROLINA

To: Kristy Thompson
From: Jesse McDaniel, CIH, CSP NC HACE
Subject: Waynesville Pharmacy
Date: March 2, 2010

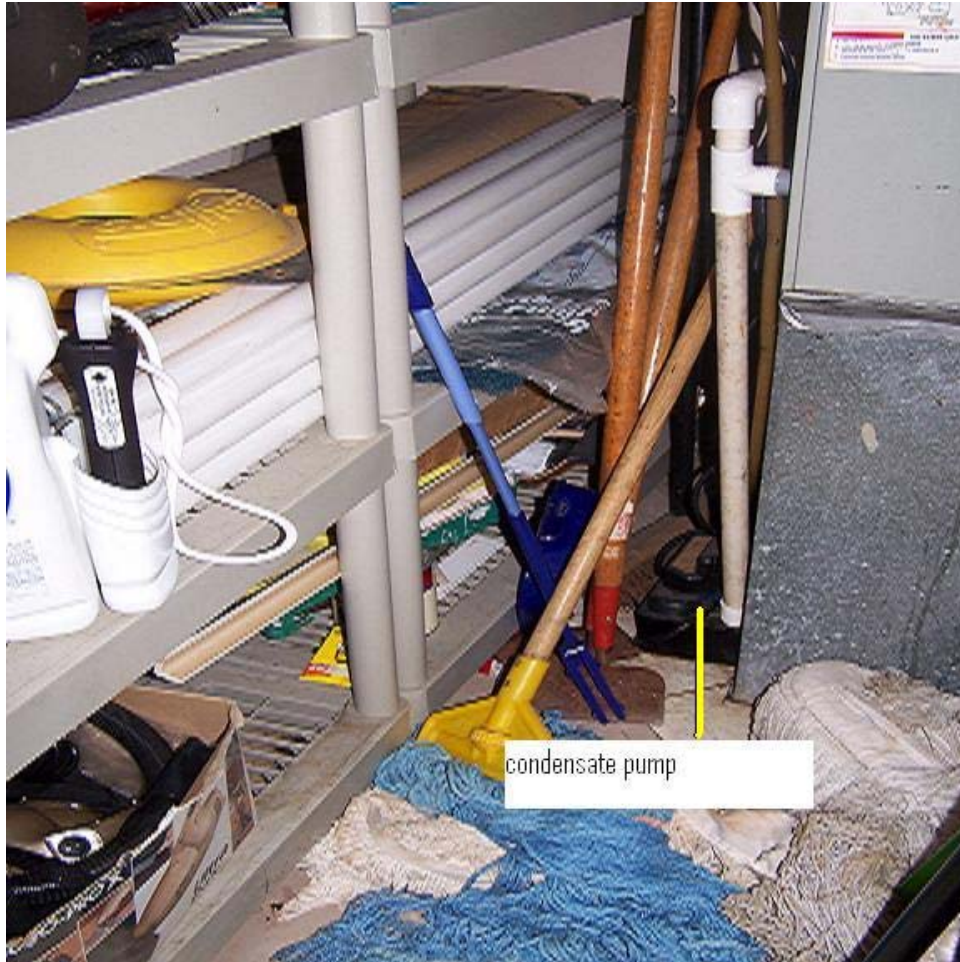
Photo 1: HVAC Condensate Pump

The public area of the pharmacy is an open design with a counter separating the pharmacy dispensing area from the rest of the store. The back of the store has a central hall with office, storage room, bathroom, and utility room. The heating ventilation and air conditioning (HVAC) system air handler is located in the utility room. Condensate is drained from the cooling coils via a 1-inch PVC pipe to a small condensate pump located on the floor (see photo 1). The condensate is pumped through quarter inch tubing to a sink in the next room. The tubing runs from the floor up to and along the ceiling to a sink located in the adjacent room. The tubing is more than 20 ft in length and microbial growth was visible in the line (see photos 2 and 3). The length of the tubing, vertical

PVC pipe leads into the condensate pump from the HVAC condensate pan. Rubber tubing exits the pump and runs along the ceiling.

NC HACE also recommends that alternatives to the current HVAC condensate tubing be investigated. A more direct pathway will decrease the likelihood of the tubing becoming plugged and water building up in the condensate pan. Routine maintenance of the HVAC system and filter replacement may also reduce upper respiratory system irritation of building occupants.

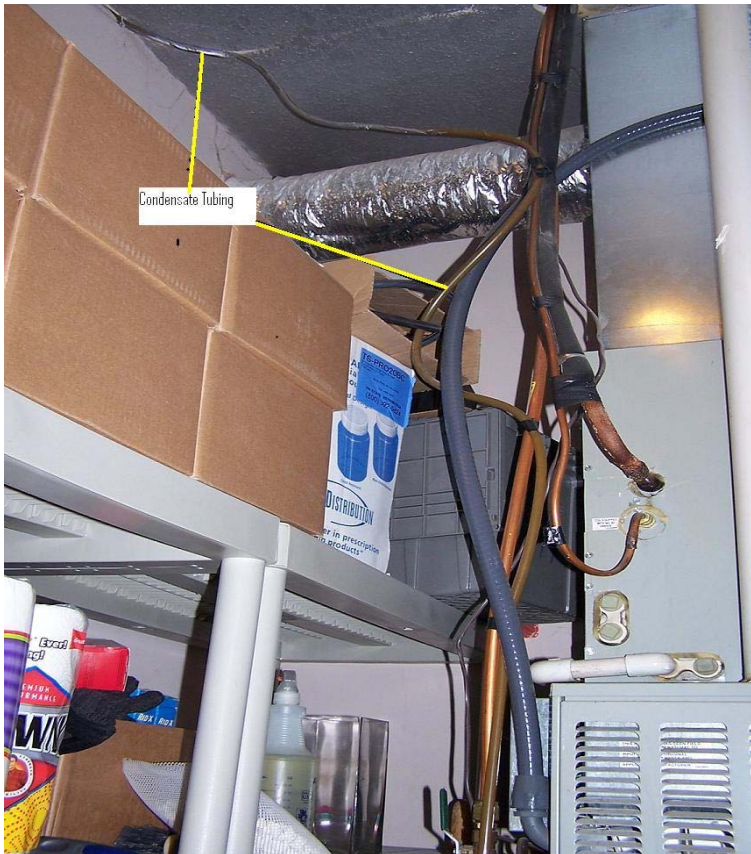
Photo 2: Condensate Tubing

rise, and microbial growth in the line may prevent the proper draining of the HVAC system condensate pan. Any resulting microbial growth in the condensate pan can be entrained in the air stream and distributed to occupied areas. This can result in a musty odor and building occupants experiencing upper respiratory system irritation.

Condensate Tubing

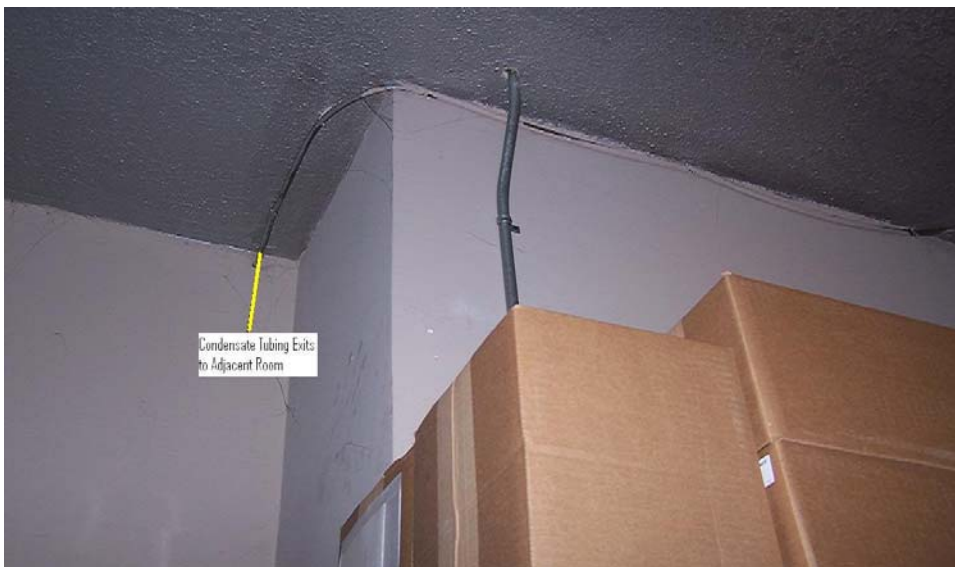
Photo 3: Condensate Tubing Along the Ceiling

Condensate Tubing Exits to Adjacent Room

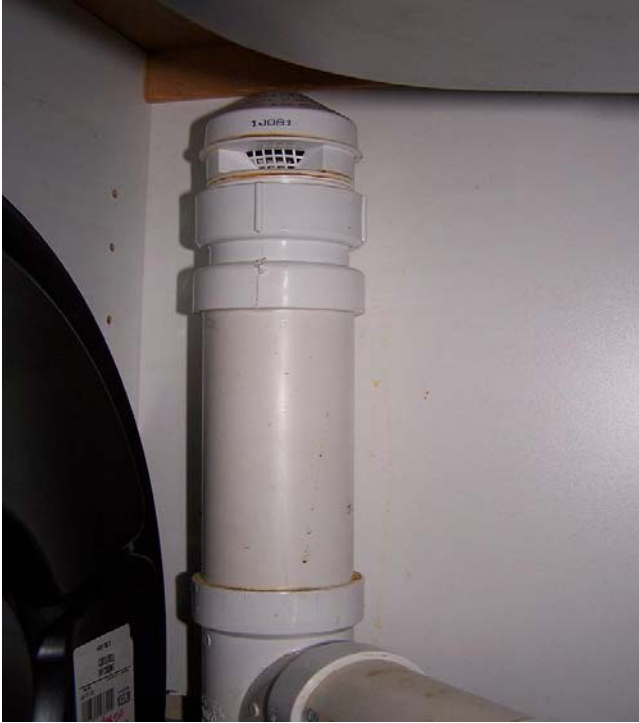
Photo 4: Air Admittance Valve

The building plumbing system utilizes air admittance valves (AAV) to minimize the number of connections to a central vent stack (see photo 4). The AAV are one way valves that are designed to open when water is discharged from the sink. This allows air to enter the plumbing system and the wastewater to properly drain. When the water flow stops, the valve re-seals and prevents sewer gas from entering the occupied building spaces. If the valve fails or is not properly attached to the PVC piping, sewer gas could enter the building. The AAV was not properly attached (loose) in at least one location (see photo 5). This or other loose fittings downstream from the water traps could account for the intermittent nature of the odor.

NC HACE recommends that the plumbing system be inspected to identify and seal any loose fittings. The AVV should also be checked to ensure the valves are operating properly. No floor drains were observed during the site visit. However, the building should be thoroughly inspected to confirm the absence of floor drains. Sewer gas could enter the occupied space if the water traps in the drains are allowed to dry out.
