Letter Health Consultation

Evaluation of Potential Exposures to Contaminants from the

CRISTEX DRUM NPL SITE

OXFORD, GRANVILLE COUNTY, NORTH CAROLINA

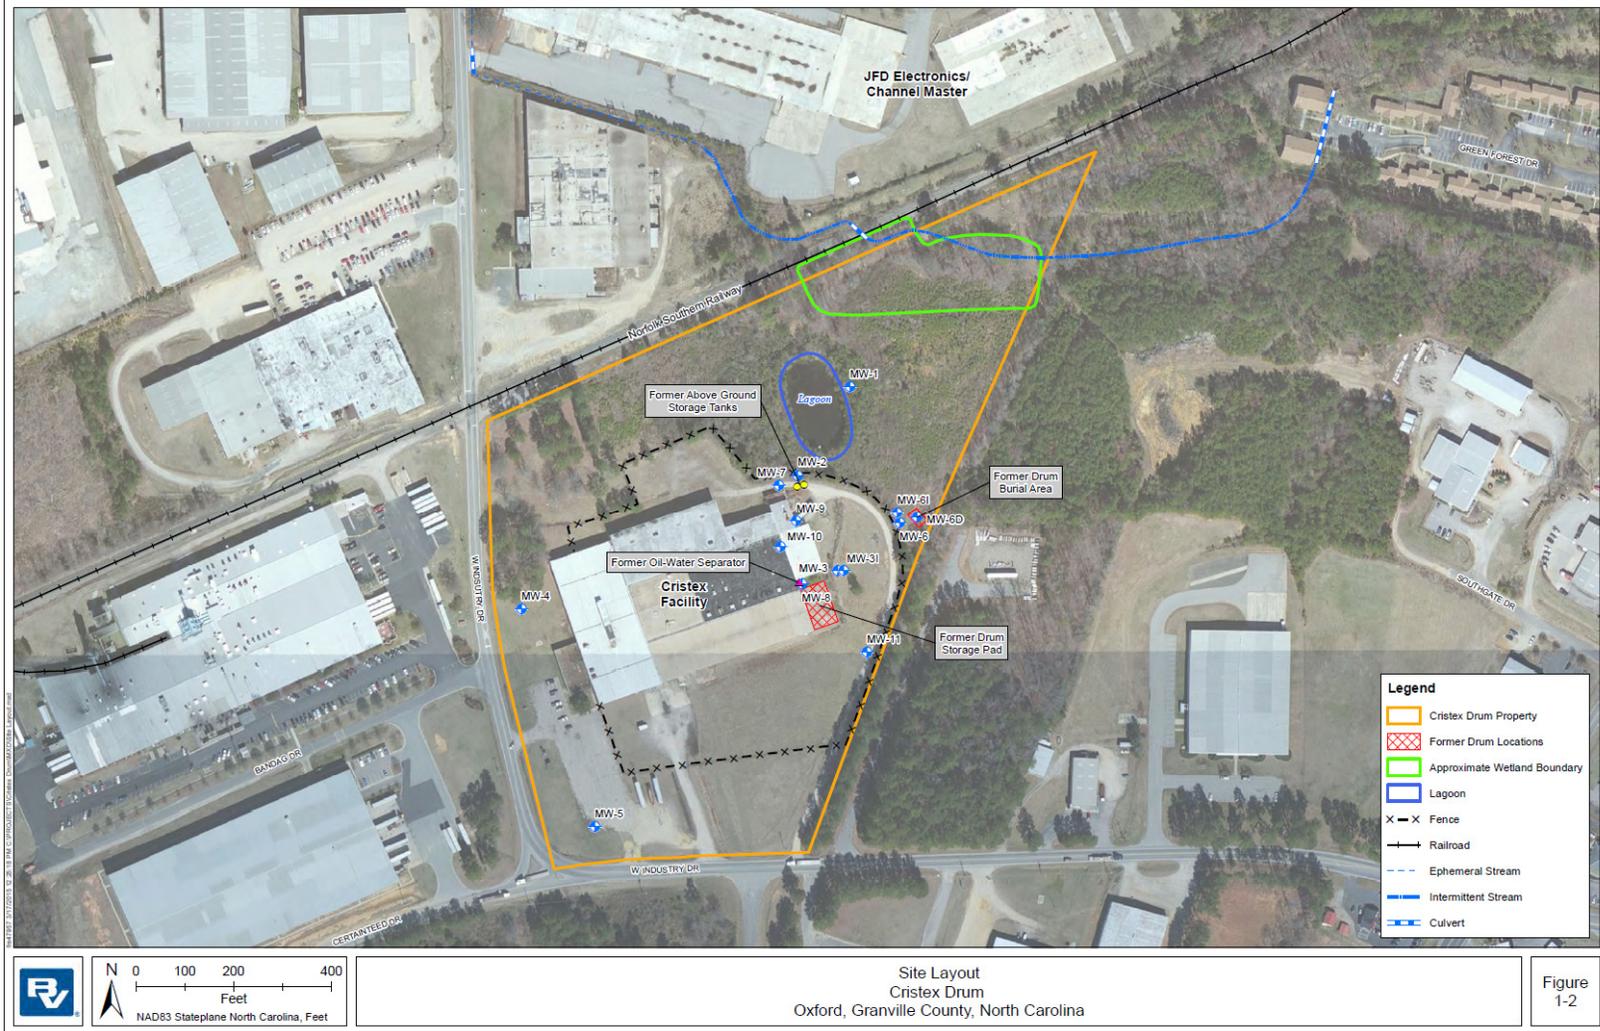
Figure 1. Cristex Drum NPL site layout. Oak Ridge Apartments are located N/NE of the Cristex facility on Green Forest Drive, visible in the upper right corner. Groundwater and surface water flows east.

The Cristex Drum NPL site (EPA ID: NC0001606250) is located on a 22-acre parcel at 500 West Industry Drive in Oxford, Granville County, North Carolina (Figure 1). It is in a primarily industrial area. The U.S. EPA is in the process of starting the Remedial Investigation for the site. The closest residential property is Oak Ridge Apartments, a complex of approximately 200 residents located approximately 1,350 feet east of the site.

In 1997, discarded and partially buried drums were discovered on the property [EPA 1997a]. The drums contained fuel oil sludge, printing ink and ink solvents [EPA 1997b]. EPA removed the drums and underlying soil. Other sources of contamination on the site were two #6 fuel oil aboveground storage tanks (removed in 2001) and a 500-750 gallon oil/water separator (removed in 1998) [MAA 2002]. Contaminated soils surrounding these sources were excavated and disposed of in permitted landfills. Impacted soils remain in the area next to the southeast drum storage pad, as well as under the building and at the northeast corner of the building (Figure 1). These areas are all within the 8-foot fence, which is kept locked.
